SGI TESTING SERVICES

Subject: Laboratory Test Results Transmittal
Connection Strength Testing
SRW Geogrids and Knob Blocks

**SCHEMATIC DIAGRAM OF TEST CROSS-SECTION
CONNECTION STRENGTH TESTING**

SRW PRODUCTS CONNECTION STRENGTH TESTING (ASTM D 6638)

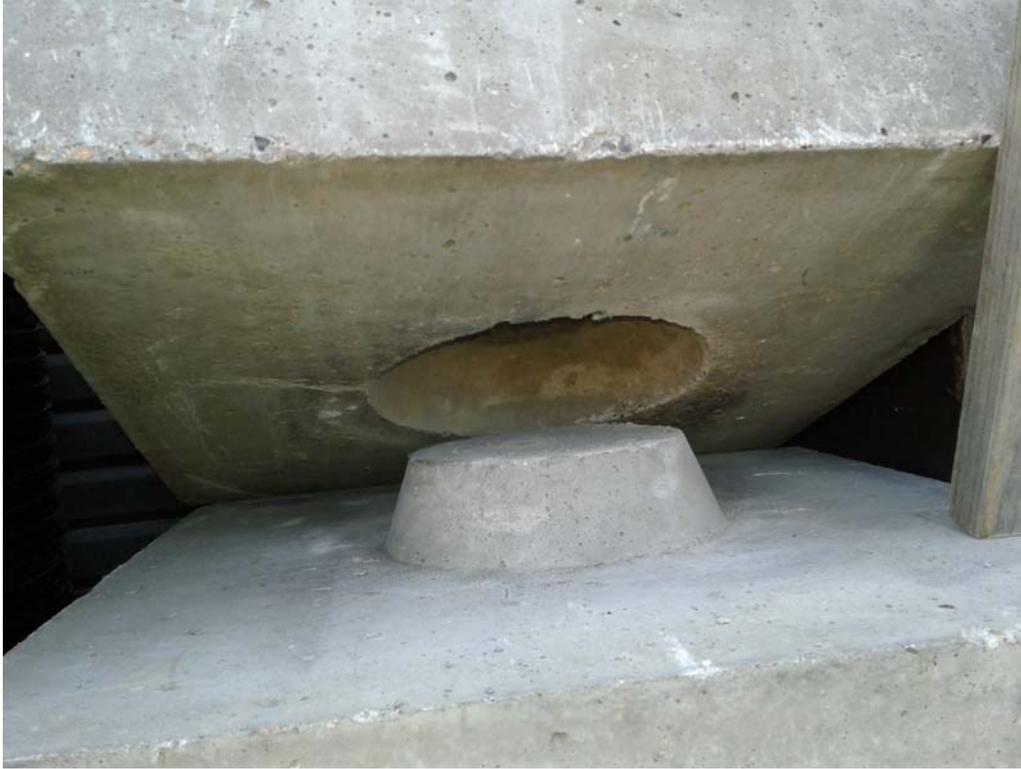
Figure A-2. Round cavity at the center of top block and knob at the center of bottom block.

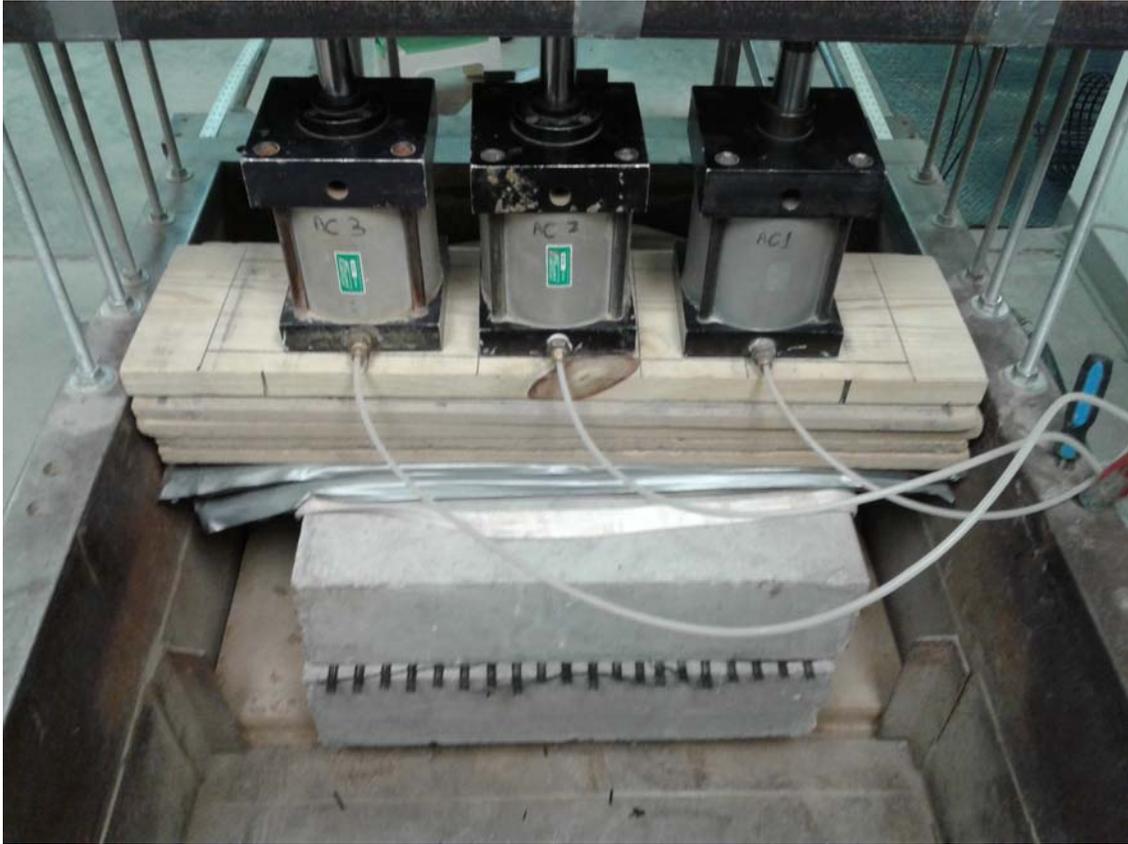
Figure A-3. Rear view of the connection test setup.

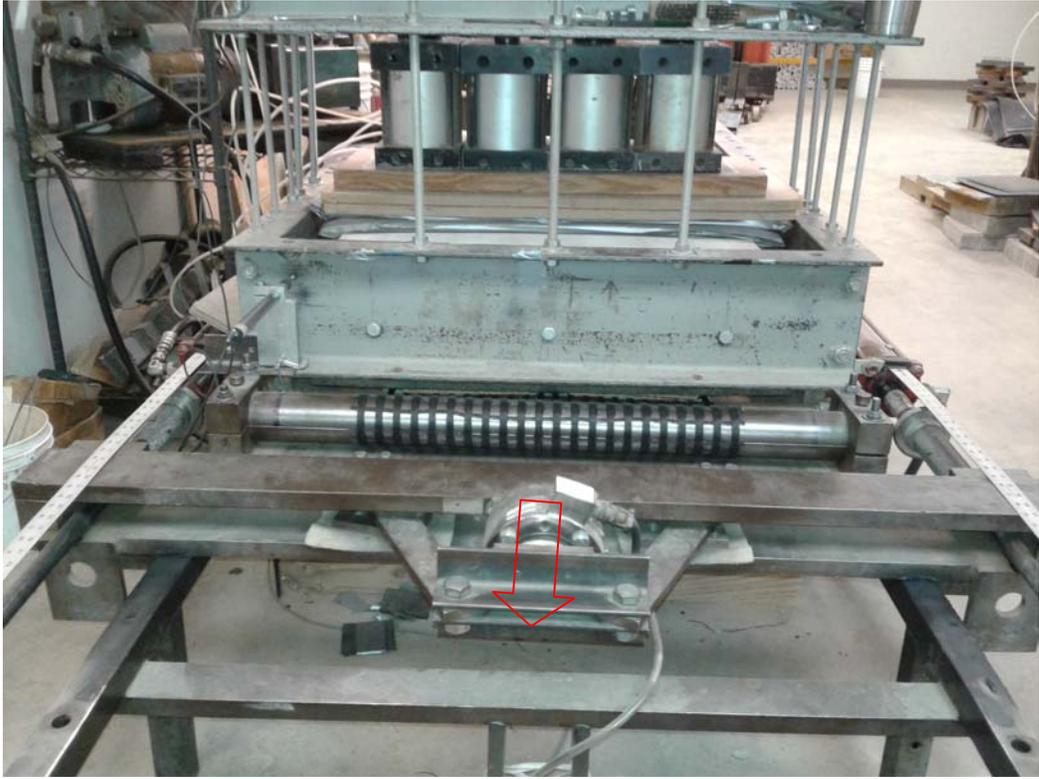
Figure A-4. Front view of the connection test setup.

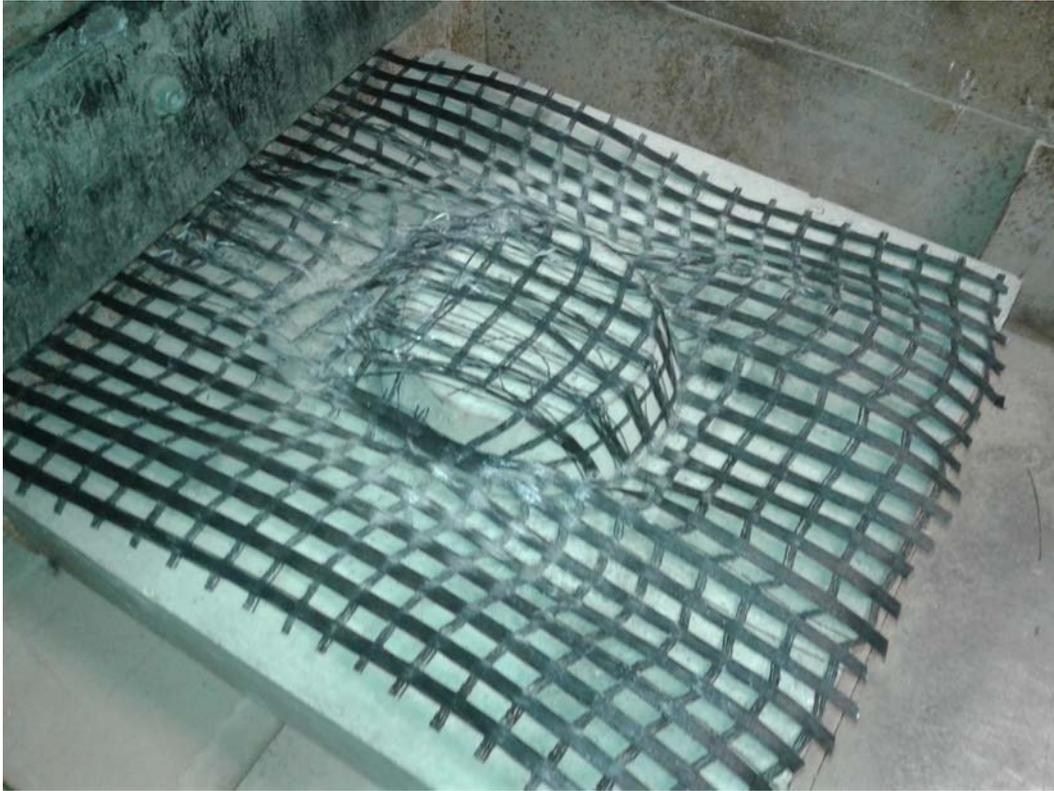
Figure A-5. Abrasion and rupture of SRW-11 geogrid ribs at the completion of a test.

Abrasion and/or rupture of geogrid ribs against the knob of blocks in each test.

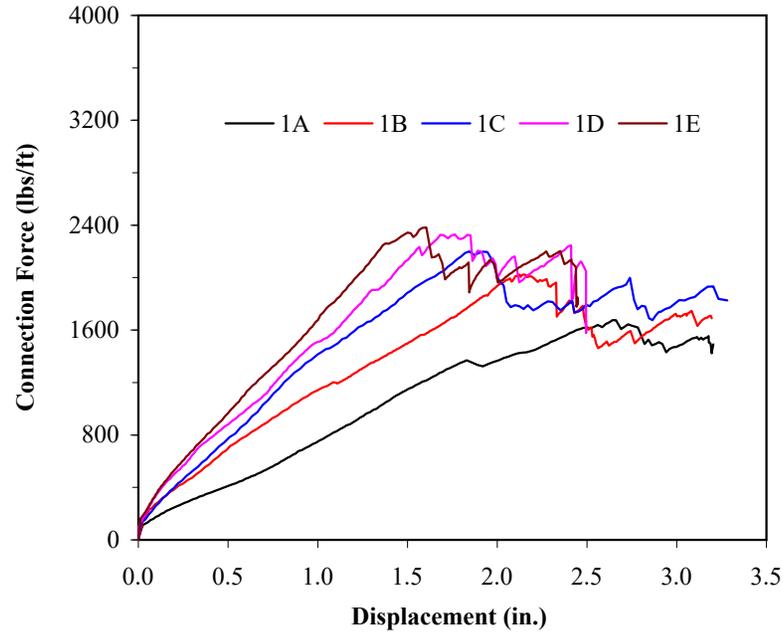
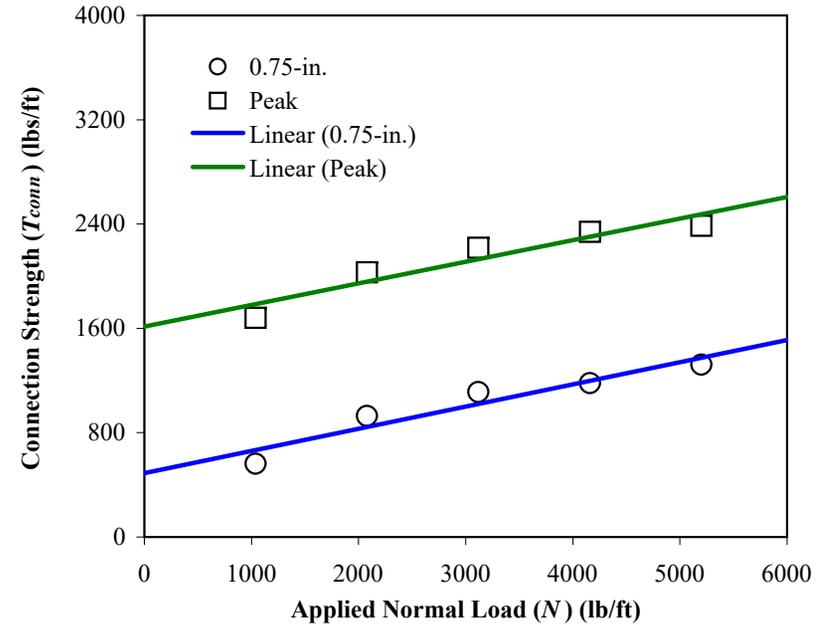
FIGURE NO. B-1

TEST SERIES NO. 1: SRW-7 geogrid in machine direction between two courses of Knob blocks
without AASHTO #57 stone

Test No.	Geogrid Specimen Width W (in.)	Test Normal Stress σ_n (psi)	Equivalent Normal Load N (lb/ft)	Approximate No. of Blocks n (-)	Approximate Wall Height h (ft)	0.75-in. Strength $I_{0.75-in}$ (lb/ft)	Peak Strength I_{peak} (lb/ft)	Connection Strength Equations (Strength assumed to be linearly related to N)
1A	23.0	3.6	1040			562	1680	$T_{0.75-in.} = 490 + (N) \tan (10^\circ)$ $T_{peak} = 1615 + (N) \tan (9^\circ)$
1B	23.0	7.2	2080			929	2028	
1C	23.0	10.8	3120			1111	2217	
1D	23.0	14.4	4160			1180	2338	
1E	23.0	18.1	5200			1322	2386

Failure Mode:

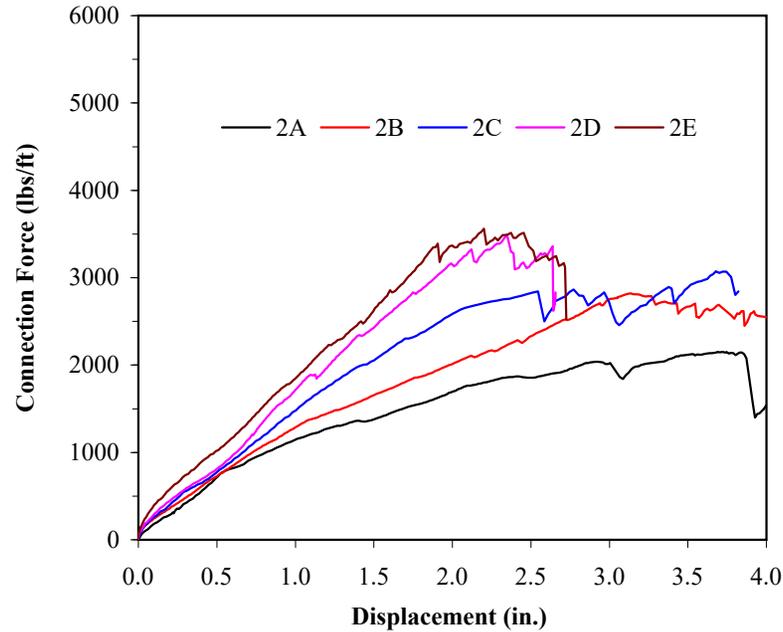
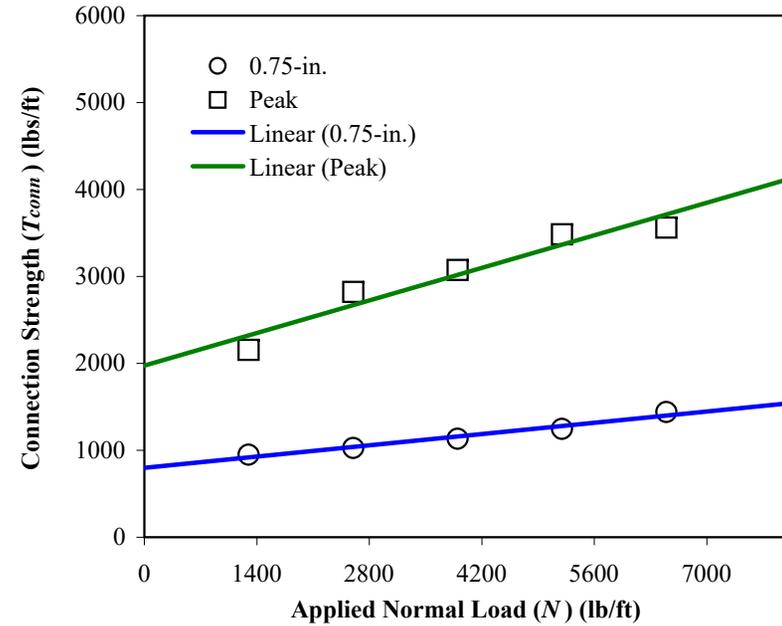
FIGURE NO. B-2

TEST SERIES NO. 2: SRW-9 geogrid in machine direction between two courses of Knob blocks
without AASHTO #57 stone

Test No.	Geogrid Specimen Width W (in.)	Test Normal Stress σ_n (psi)	Equivalent Normal Load N (lb/ft)	Approximate No. of Blocks n (-)	Approximate Wall Height h (ft)	0.75-in. Strength $T_{0.75-in}$ (lb/ft)	Peak Strength T_{peak} (lb/ft)	Connection Strength Equations (Strength assumed to be linearly related to N)
2A	23.0	4.5	1300			949	2152	$T_{0.75-in.} = 800 + (N) \tan (5^\circ)$ $T_{peak} = 1975 + (N) \tan (15^\circ)$
2B	23.0	9.0	2600			1027	2822	
2C	23.0	13.5	3900			1131	3072	
2D	23.0	18.1	5200			1244	3485	
2E	23.0	22.6	6500			1441	3561

Failure Mode:

Abrasion and/or rupture of geogrid ribs against the knob of blocks in each test.

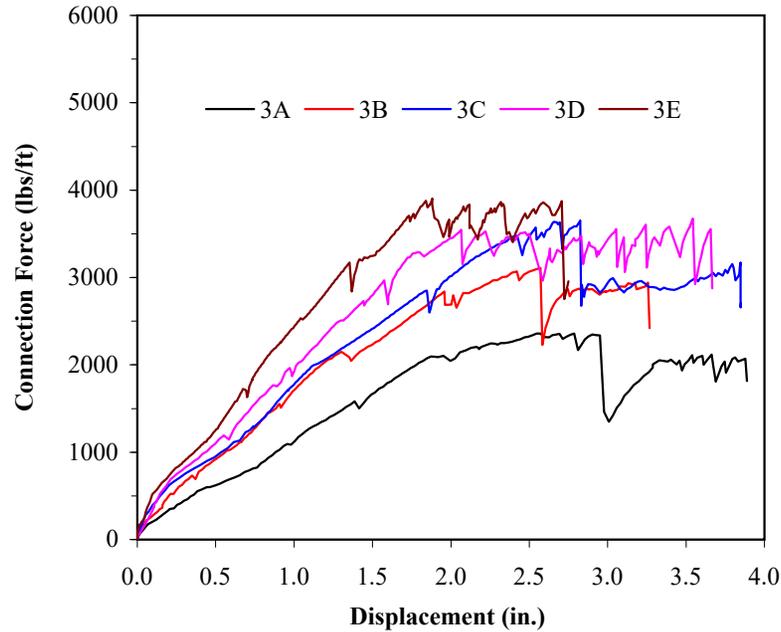
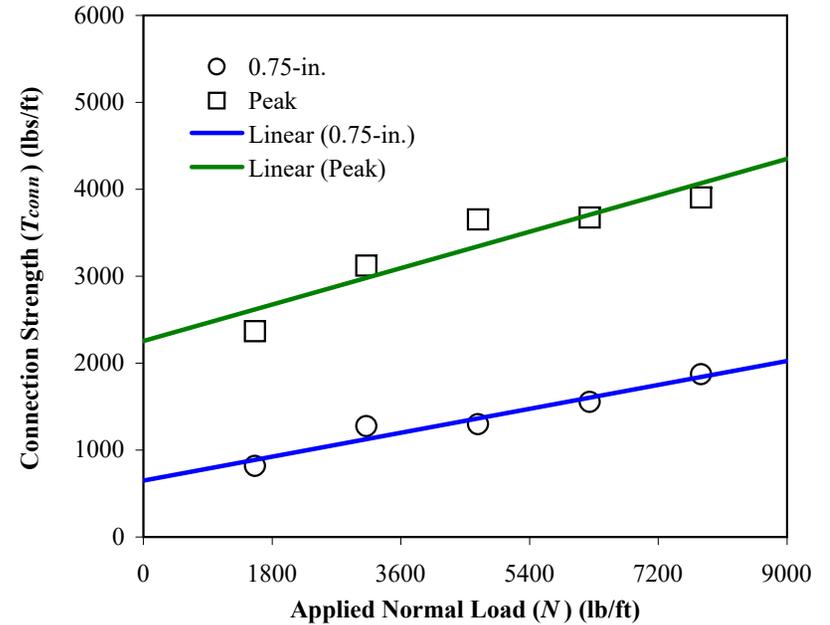
FIGURE NO. B-3

TEST SERIES NO. 3: SRW-11 geogrid in machine direction between two courses of Knob blocks
without AASHTO #57 stone

Test No.	Geogrid Specimen Width W (in.)	Test Normal Stress σ_n (psi)	Equivalent Normal Load N (lb/ft)	Approximate No. of Blocks n (-)	Approximate Wall Height h (ft)	0.75-in. Strength $I_{0.75-in}$ (lb/ft)	Peak Strength I_{peak} (lb/ft)	Connection Strength Equations (Strength assumed to be linearly related to N)
3A	23.0	5.4	1560			818	2367	$T_{0.75-in.} = 645 + (N) \tan (9^\circ)$ $T_{peak} = 2255 + (N) \tan (13^\circ)$
3B	23.0	10.8	3120			1275	3120	
3C	23.0	16.3	4680			1297	3651	
3D	23.0	21.7	6240			1553	3676	
3E	23.0	27.1	7800			1872	3906

Failure Mode:

Abrasion and/or rupture of geogrid ribs against the knob of blocks in each test.
